**State of California
The Resources Agency
DEPARTMENT OF WATER RESOURCES
Division of Flood Management**

**JUNE
2003
OFFICE REPORT**

**THE INSPECTION OF FLOOD CONTROL STRUCTURES
ON THE SACRAMENTO AND SAN JOAQUIN RIVERS
AND THEIR TRIBUTARIES**

**Prepared By The
Flood Operations Branch
FLOOD PROJECT INSPECTION SECTION**

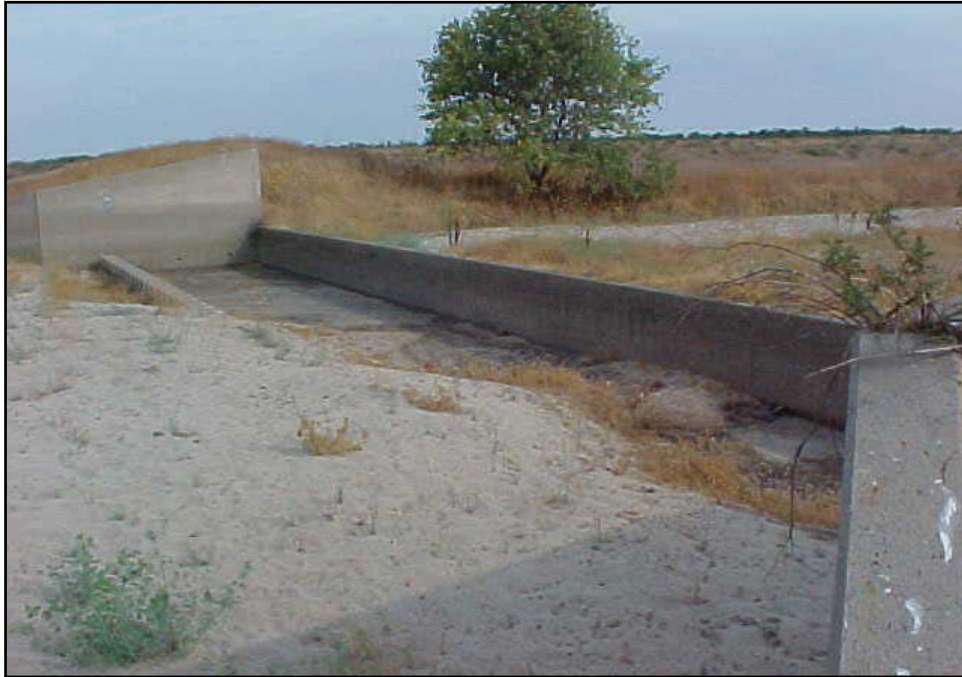
ASH SLOUGH DROP STRUCTURE NO. 3

- 1. Condition of concrete drop structure, stilling basin and velocity dissipaters.**
 - a. Good, except the velocity dissipaters are covered with sand.**
- 2. Condition of concrete abutments and wing walls.**
 - a. Good.**
- 3. Condition of revetment.**
 - a. Good.**
- 4. Accumulation of trash and debris around the structure or in the channel.**
 - a. None.**
- 5. Vegetation around the structure or in the channel.**
 - a. None.**
- 6. Comments:**
 - a. This structure is in good condition but needs to have the sand removed from the stilling basin and from around the velocity dissipaters.**
 - b. Fair maintenance.**

**Looking at the partially sand filled stilling basin.
The velocity dissipaters are covered by sand.**

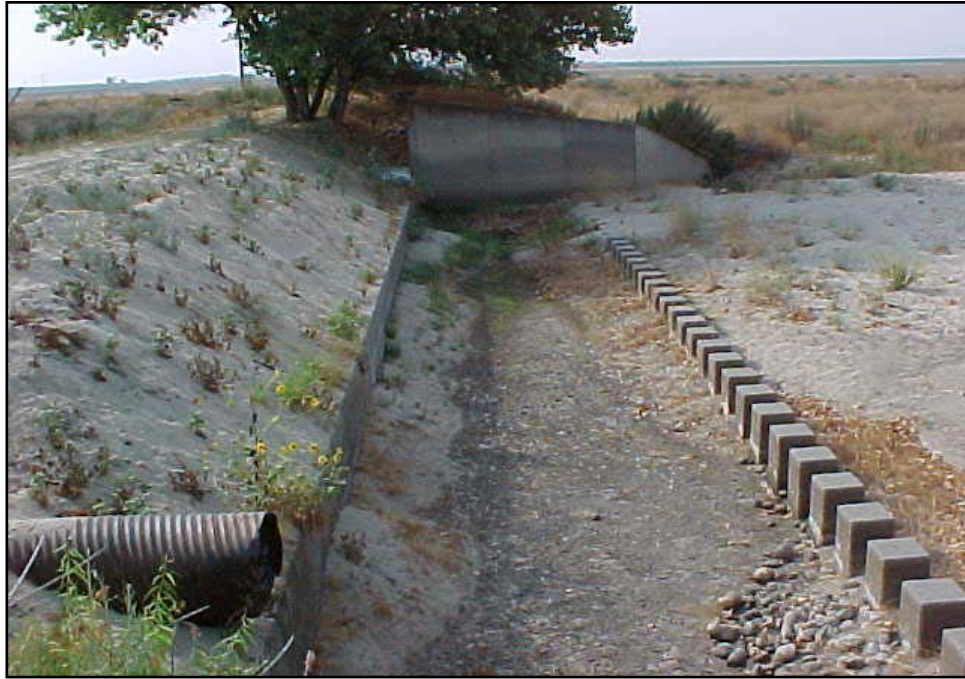
ASH SLOUGH DROP STRUCTURE NO. 4

- 1. Condition of concrete drop structure, stilling basin, and velocity dissipaters.**
 - a. What can be seen is in good condition, but a seasonal sand dam is in place backing up water for irrigation purposes on the upstream side.**
- 2. Condition of concrete abutment wing walls.**
 - a. Good.**
- 3. Condition of revetment.**
 - a. Good.**
- 4. Accumulation of trash and debris around the structure or in the channel.**
 - a. None.**
- 5. Vegetation around the structure or in the channel.**
 - a. Bamboo growing along right wing wall.**
- 6. Comments:**
 - a. The seasonal sand dam on the upstream side is for irrigation purposes and can be easily breached or washed out in the event of high water.**
 - b. Remove bamboo.**

**Looking at the downstream side of the drop
structure and the seasonal sand dam.**

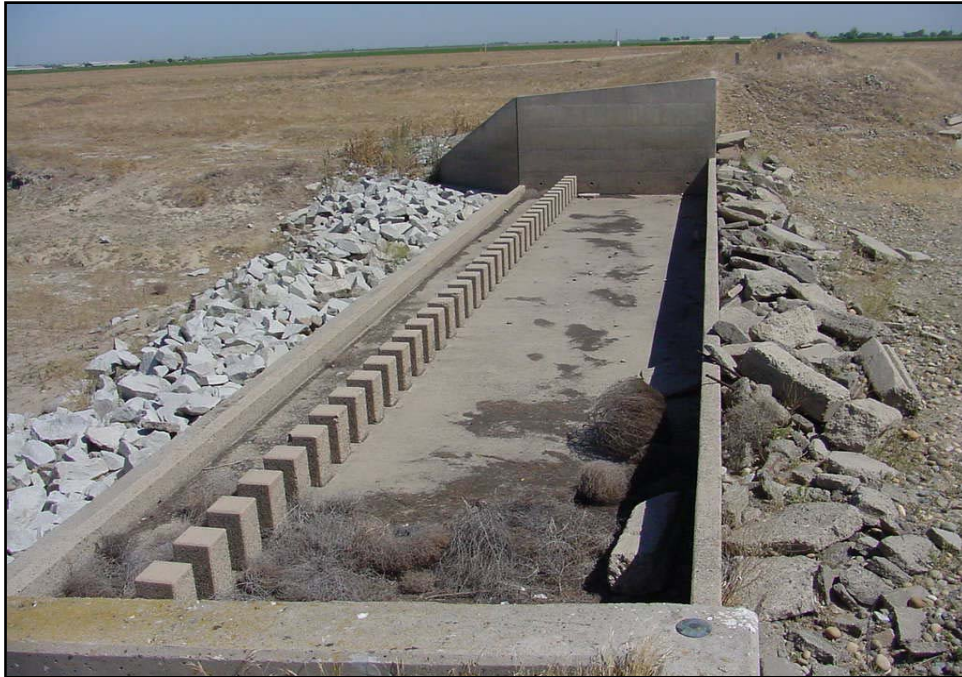
EASTSIDE BYPASS DROP STRUCTURE NO. 1
(Upstream)
Maintained by
Lower San Joaquin Levee District
June 2003

- 1. Condition of concrete drop structure, stilling basin and velocity dissipaters.**
 - a. Good.**
- 2. Condition of concrete abutments and wing walls.**
 - a. Good.**
- 3. Condition of revetment.**
 - a. Good.**
- 4. Accumulation of trash and debris around the structure or in the channel.**
 - a. Minimal.**
- 5. Vegetation around the structure or in the channel.**
 - a. None.**
- 6. Comments:**
 - a. Good maintenance.**

Looking north at the stilling basin and the velocity dissipaters.

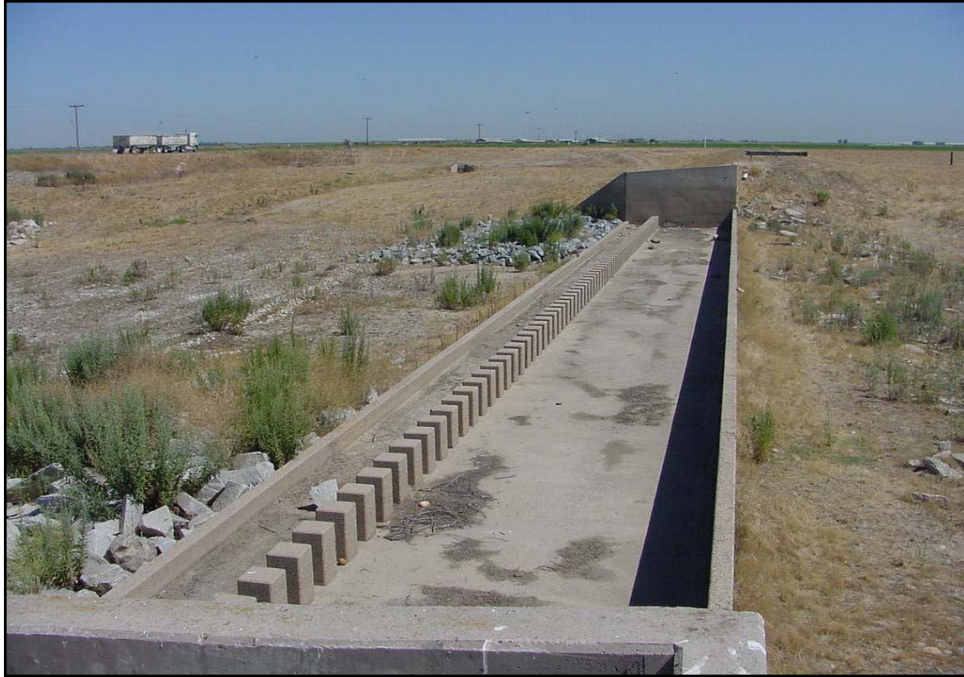
EASTSIDE BYPASS DROP STRUCTURE NO. 2
(Downstream)
Maintained by
Lower San Joaquin Levee District
June 2003

- 1. Condition of concrete structure, stilling basin, and velocity dissipaters.**
 - a. Good.**
 - b. It has been noted in past reports that concrete spalling exists on the floor of the stilling basin. This was first noted in 1969.**
- 2. Condition of concrete abutments and wing walls.**
 - a. Good.**
- 3. Condition of revetment.**
 - a. Good.**
- 4. Accumulation of trash and debris around the structure or in the channel.**
 - a. None.**
- 5. Vegetation and debris around the structure or in the channel.**
 - a. None.**
- 6. Comments:**
 - a. Good maintenance.**

Looking north at the structure.
Road 9 is in the background.

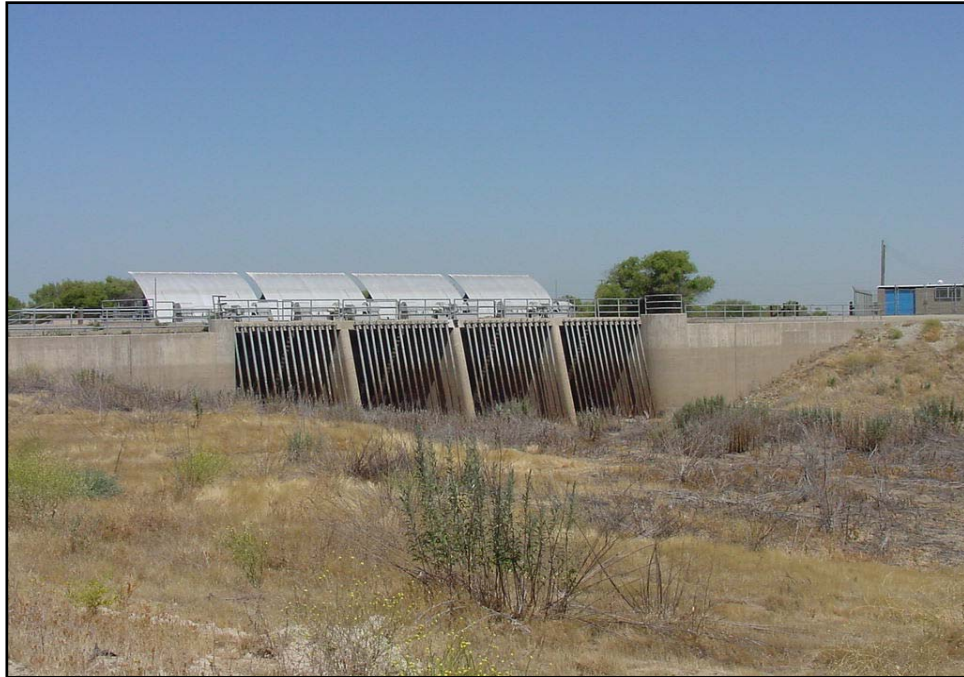
**SAN JOAQUIN RIVER AND
CHOWCHILLA CANAL BYPASS CONTROL STRUCTURE**
Maintained by
Lower San Joaquin Levee District
June 2003

- a. All the equipment is tested and serviced prior to flood season each year. This structure is well maintained and is in excellent condition.**
- b. Good maintenance.**

Looking at the upstream side of the San Joaquin River structure.

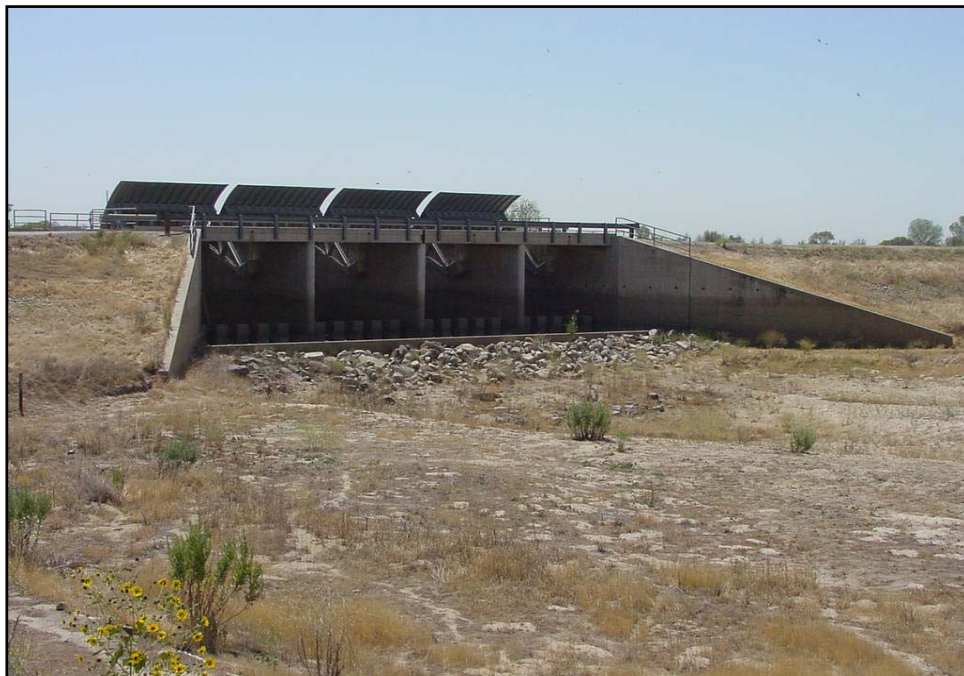
Looking at the downstream at the San Joaquin River structure.

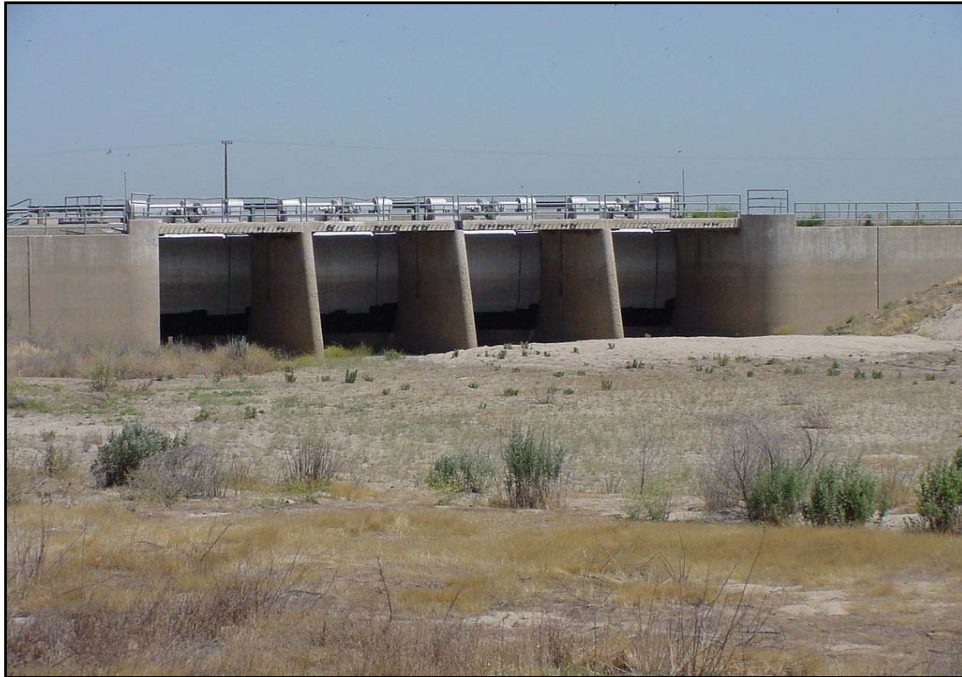
**SAN JOAQUIN RIVER AND
CHOWCHILLA CANAL BYPASS CONTROL STRUCTURES**
Maintained by
Lower San Joaquin Levee District

Looking at the upstream side of the Chowchilla Canal Bypass structure.

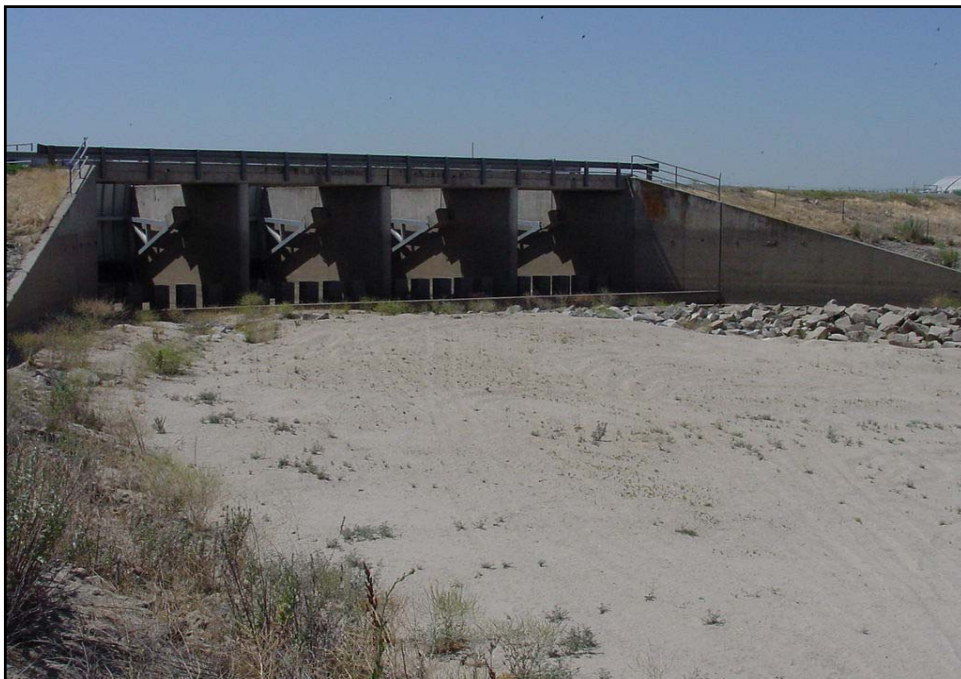
**Looking at the discharge side of the structure
into the Chowchilla Canal Bypass.**
